Electrical Installation Appraisal Report

The Property
Our Road
This Town

Part 3: Summary of the Report on the Condition of the Installation

The overall assessment of this installation is **Unsatisfactory**

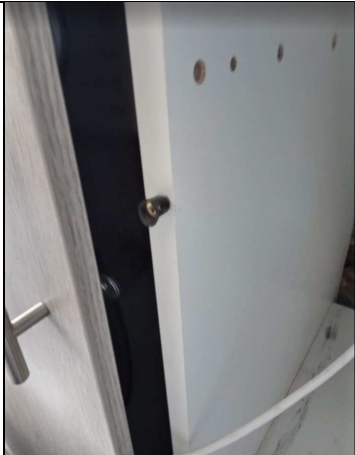
<p>Fig 1 Damaged Oven Fixings left</p>

Number	Details	Fig	Code	Regulation
1	Oven is mounted proud of oven housing. Security of fixing of concern.	1,2	FI	133.3 Conditions of Installation 134.1.1 Erection of Installation
2	Potential overload of socket for oven. The oven power rating is unknown and may exceed the 13A rating of the plug and socket.	3,5,6	FI	433.1 Coordination between conductor and overload protective device
3	Isolators inaccessible behind fridge/freezer. These control the oven/hob and	4	C2	513.1 Accessibility of equipment 537.3.3.6 Devices for emergency switching
3	Isolators behind fridge/freezer not secured. Screws are in front of the switches. Mounting boxes not secured	18,19	C2	134.1.1 Erection of Installation
4	Consumer unit has missing blank, causing failure of IP rating. Incorrect blanks installed in cover of consumer unit.	9,10	C1	416.2.1 Access to live parts within enclosures
5	Consumer unit of plastic construction under wooden staircase with no signs of overheating	9,10	N/A	421.1.201 Consumer units must be on non-combustible material

It is recommended that the faults identified are rectified. It is also recommended that an Electrical Installation Condition Report is prepared for this property. This will be to investigate the remainder of the installation for further defects. From the observations made, it has been assumed that the property does not have a current EICR. All rental properties are required to have a current EICR or installation certificate.

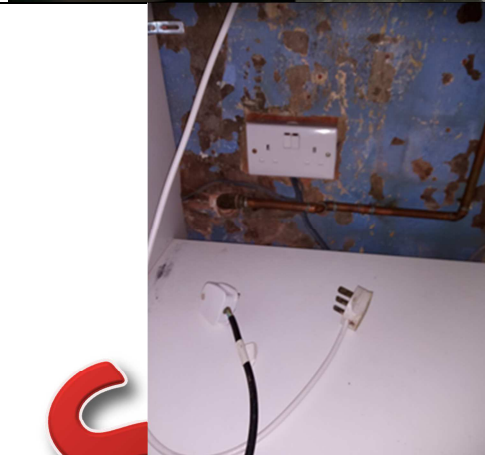
Fig 6.
Socket for oven
and hob

10	Service head seals have been damaged or removed and not replaced. Risk of electric shock.	11	C2	642.3 Basic protection
11	Exposed copper on neutral meter tail within consumer unit	10	C2	134.1.1 Erection of Installation
12	Exposed insulation on oven flex.	6	C2	134.1.1 Erection of Installation
13	Unsecured cables behind fridge/freezer	17,18	C2	134.1.1 Erection of Installation 522.8.4 Support of cables 522.8.5 Support of cables

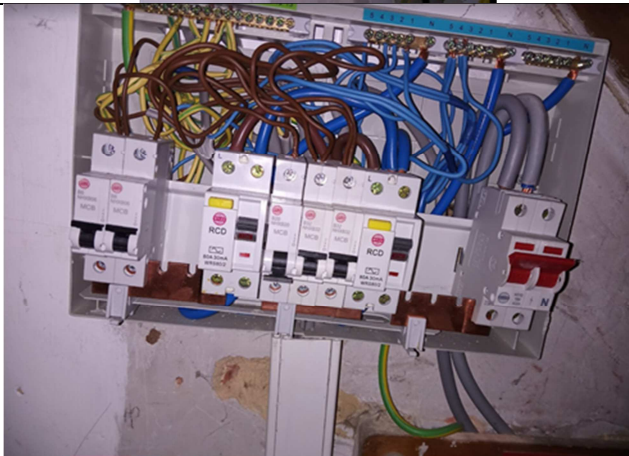
<p>Fig 10. Consumer unit</p>

6	Loose cables near gas meter. These have been returned to the trunking during our visit.	12,13,20	C2	134.1.1 Erection of Installation
7	Connection of CPC and Neutral conductors in consumer unit are not in the correct locations.	10	C2	134.1.1 Erection of Installation
8	Unenclosed cable joint above kitchen cabinets	14	C2	526.5 Enclosures for termination of joints.
9	Isolators behind fridge/freezer control multiple items of equipment. Individual isolation is not present. Risk of overload of switch.	N/A	C2	433.1 Coordination between conductor and overload protective device
